Historic Preservation Project:
State Exchange Bank Building, Culver, Indiana:
the bank that Good Will built

Submitted By
Chad A Gard
4675218

HIST634 D001 Spring 2017

Submitted to the Department of History
30 July, 2017

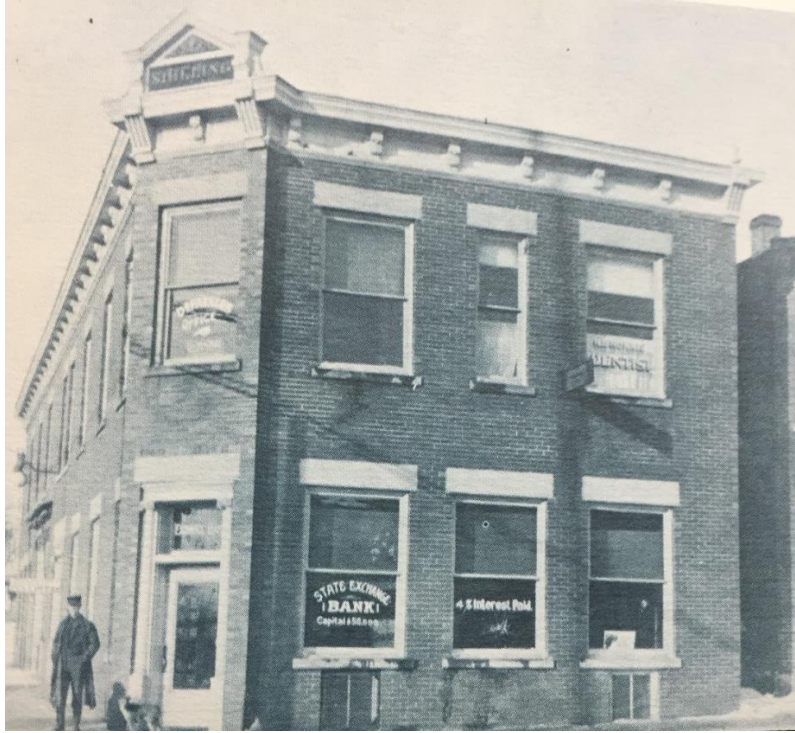
Figure 1: State Exchange Bank, Culver, 19 December 1921, following robbery. Note bullet holes, dentists' office on 2nd floor

The building featured a beautiful early 20th century functional architecture, featuring a brick façade, capped with limestone lintels, and included an angled “left” side on the corner. This feature was repeated on the branches opened in Argos and LaPaz as well (see figures 1, 2, and 3).

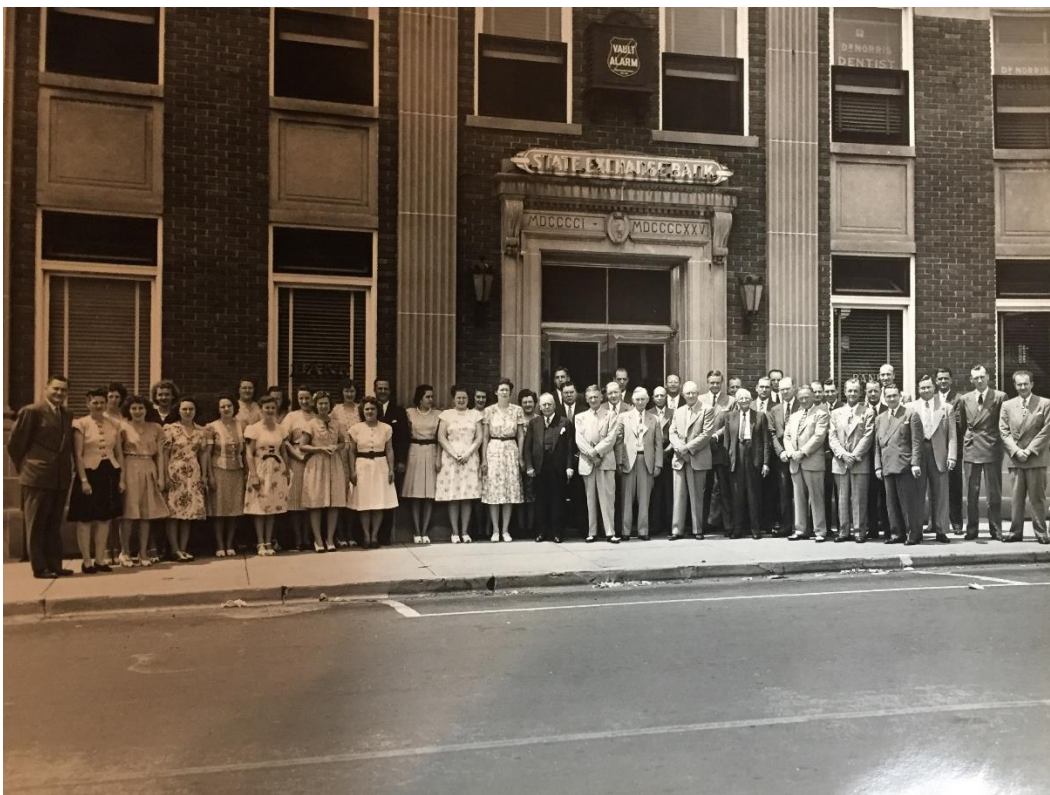
Figure 4: Main St. Façade, 1947.¹⁷

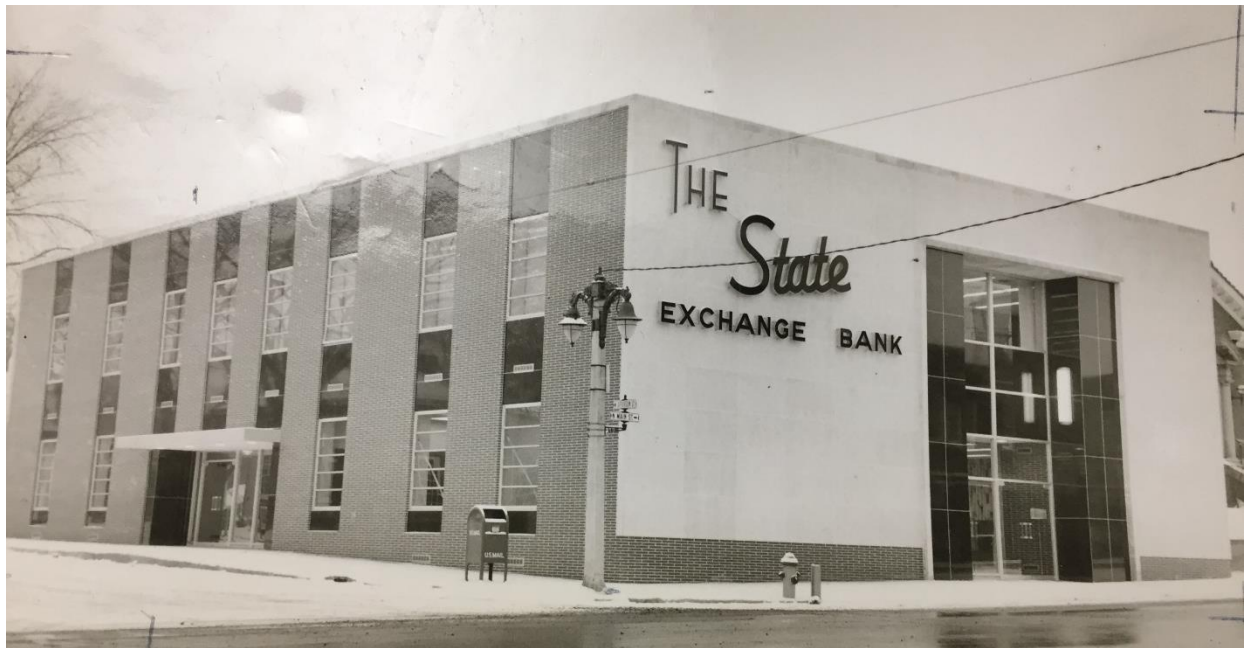
Figure 5: State Exchange Bank, 1958.¹⁹

In 1958, the building underwent a rather unfortunate extensive remodel into essentially its present form. This type of brutalist, “fully modern” design was popular throughout the 1960’s and 1970’s, proving the bank as once again ahead of its time. Unfortunately, the new façade does not integrate into its existing context well. This was not of particular concern at the time, as the management of the bank was clearly enthusiastically marketing its buildings as “sleekly ultramodern and tailored to tomorrow.”¹⁸

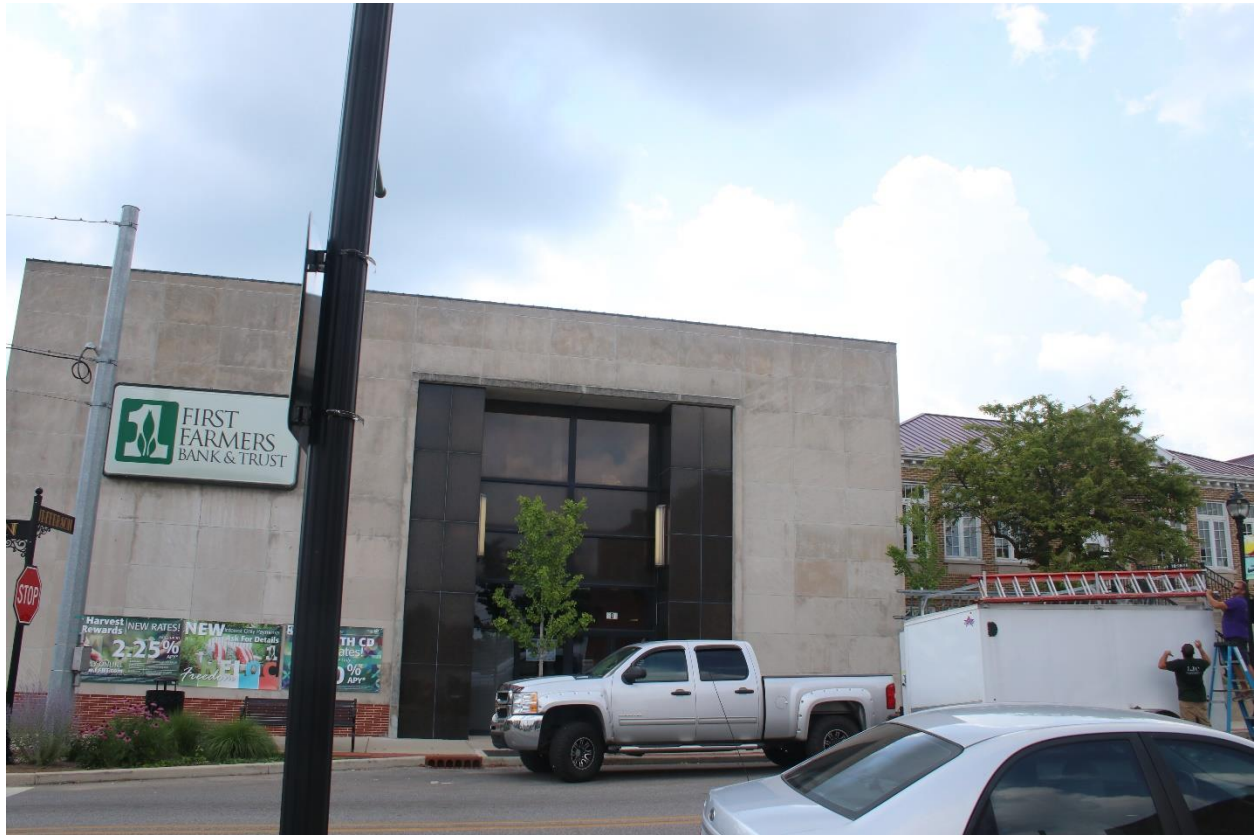
Figure 6: Main Street Facade is rather cold and impersonal, given the historic architecture of the rest of the district. Note the proximity of the Carnegie Library (hiding behind construction trailer).²¹

Today’s building continues to feel out-of-place. It is the only commercial building within the National Register of Historic Places listed Main Street Historic District deemed non-contributing. This is unfortunate, given the beauty the building once had, and it’s prominent role in the life of Culver. Its contextual issues are exacerbated by its prominent location next to the 1915 Carnegie Library, a high-traffic and iconic building. The loss of the angled corner is also

unfortunate. Recovering this would open up views of the library, the Heritage Park pocket park maintained by the Culver Antiquarian and Historical Society, and the 1935 post office built by the Works Progress Administration.²⁰

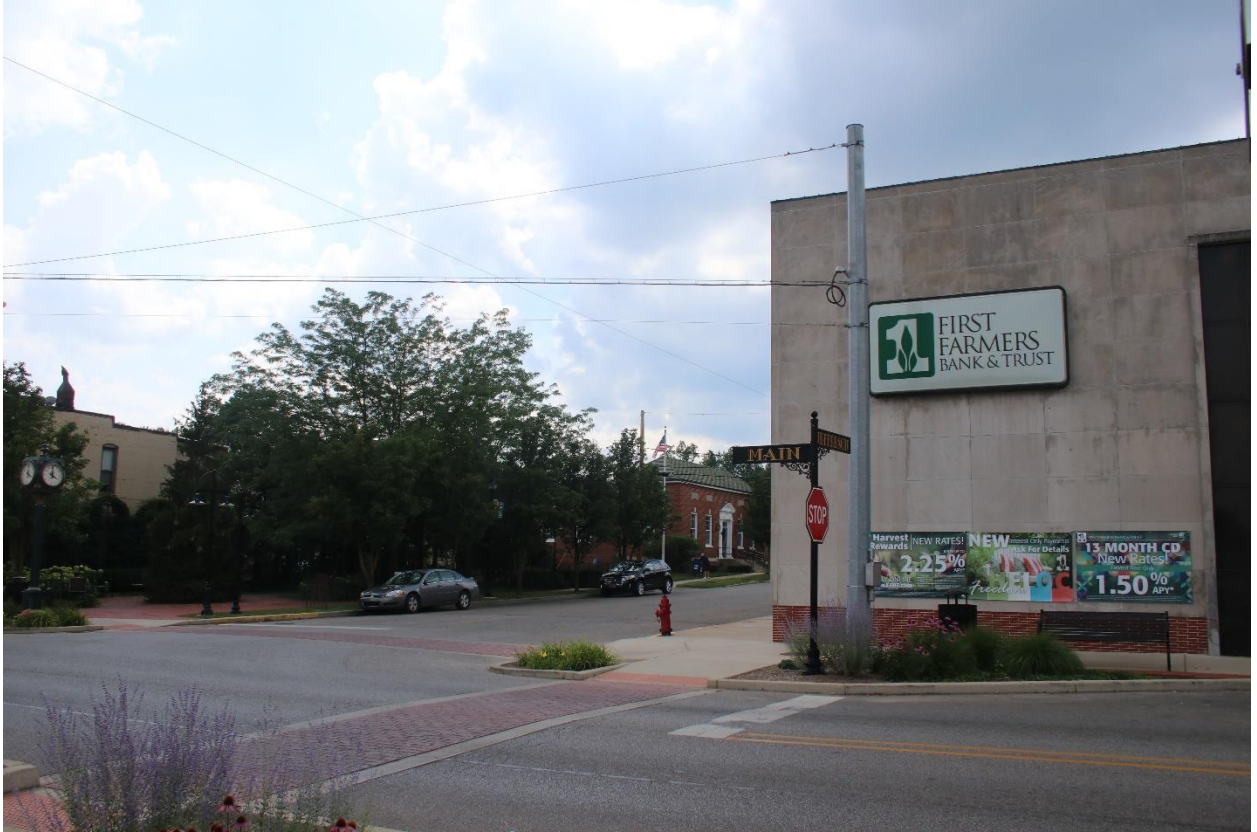
Figure 7: Corner of Jefferson and Main Streets. The current facade is clearly incongruous. Note the WPA post office in the distance, AHS pocket park across Jefferson Street, historic commercial building far left.

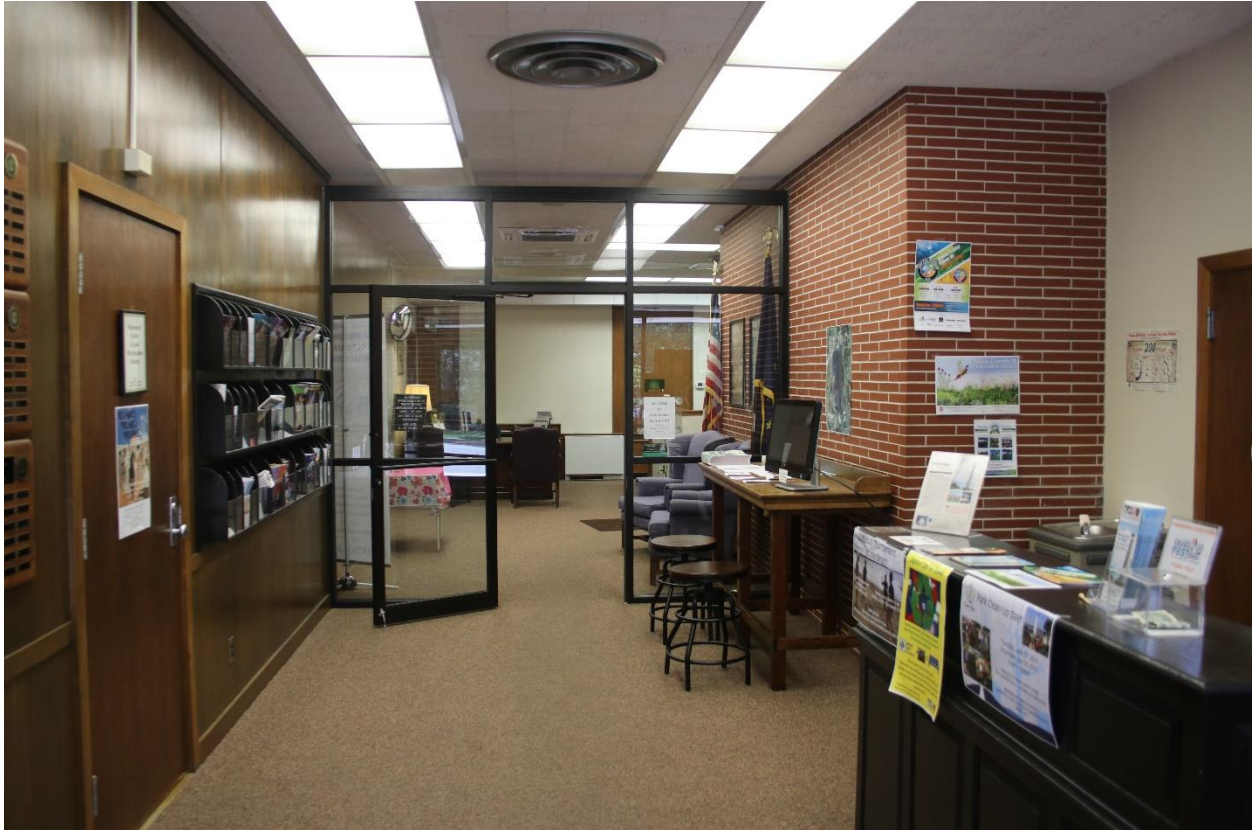
Figure 8: Jefferson Street entry. Bank lobby ahead, museum through door on left, and essentially inside the visitors' center.

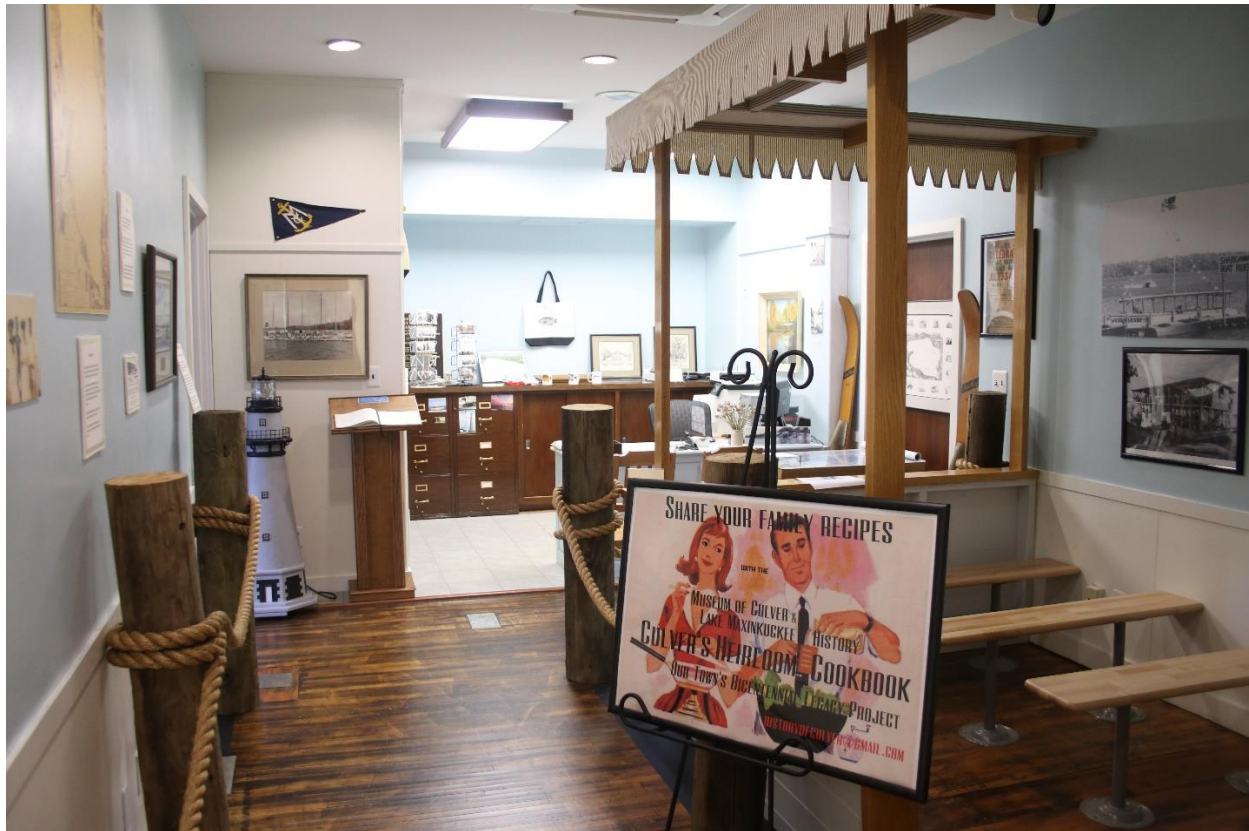
Figure 9: Entry to Museum of Culver and Lake Maxinkuckee History. Steam boat deck replica to right, secretaries used to be here.

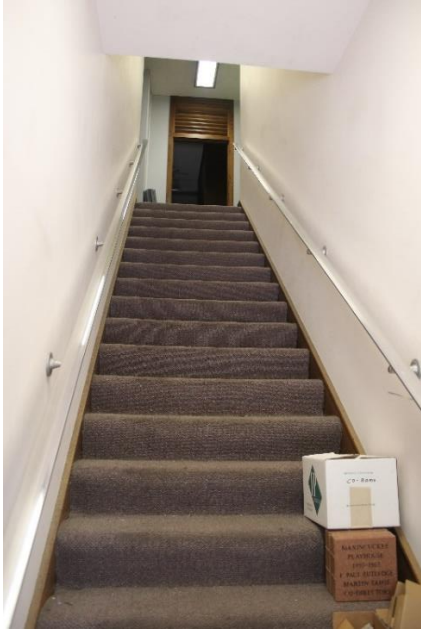
The second floor is a labyrinth. It is not publically accessible, accessed by a steep, long, and narrow stairway (though there is a dumbwaiter, which no longer functions), which does not meet modern access requirements. Offices, workspaces, restrooms, and kitchens seem to endlessly connect one to the other, with no hallway or logical traffic flow. Working here must have been a very social experience! The east side windows offer a beautiful view of the lake, a rare premium in Culver!

Figure 10: Stairway to Second Floor. Narrow, Steep, Hot.

least three residential apartments or offices. Two could serve to address the shortage of affordable housing in Culver, while the third, owing to a good view of the lake, would garner higher rent, whether for residential or office use. The stairway would need to be replaced with one acceptable to current building code, and an elevator provided (perhaps using space partly occupied by the current dumbwaiter) for Americans with Disabilities Act compliance.

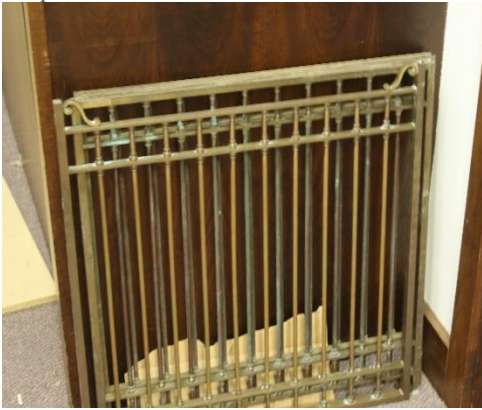
Figure 12: I literally stubbed my toe on this grate. It might be one of the teller window grates from an earlier iteration of the bank?

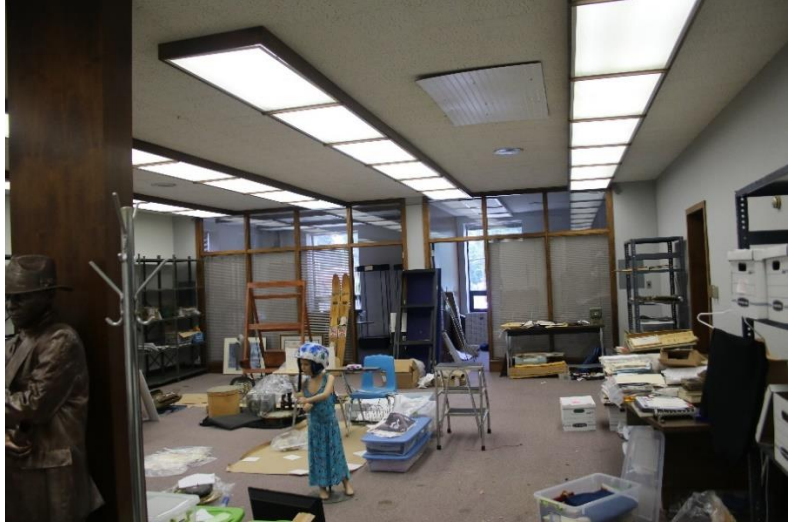
It is used for storage by the museum, and also contains various cast-off banking and office equipment of 1970's vintage, basically abandoned when the State Exchange Bank closed. There is a great deal of water damage from roof leaks, though the leaks have been repaired recently, in part through a grant received by the museum. However, the lack of climate control and presence of many allergens makes the space unlivable for many of the Antiquarian and

Figure 11: Second Floor museum storage. Just one of at least a dozen rooms.

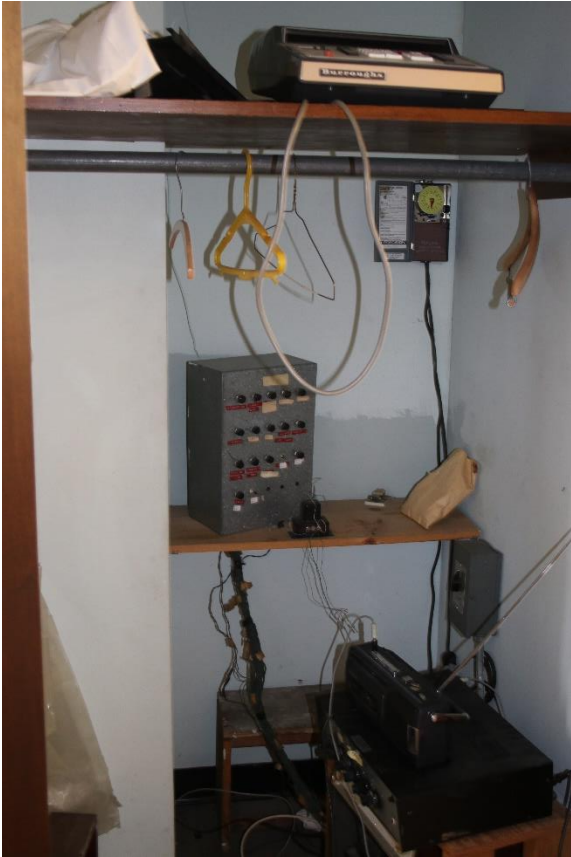
Figure 14: This intercom system on the second floor is still functioning, providing lobby music.

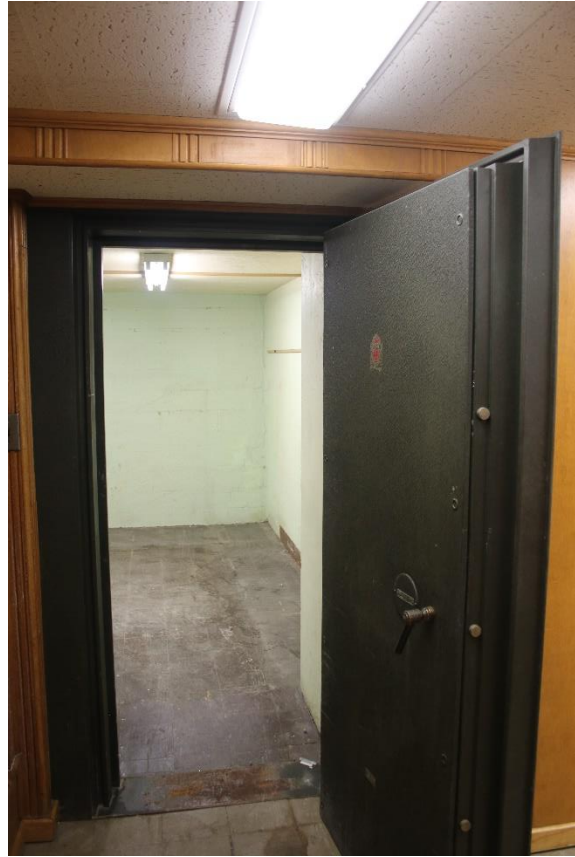
Figure 15: This basement vault retains its door. This may be the vault in which mint oil was stored.

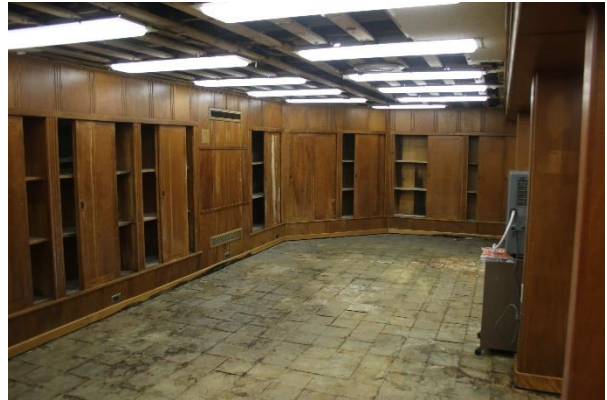
As challenging and disheartening as exploring the second floor is, the basement presents cause for greater concern. This space once housed the employee cafeteria and its kitchen. During the 1930's, this service was also opened to members of the community who found food difficult to come by. It also housed two additional vaults, a photographic dark room, and large storage rooms, as well as utility spaces.

Figure 17: Employee Dining Hall today. The wall clock shown in Fig. 16 is still present on the wall to the right.

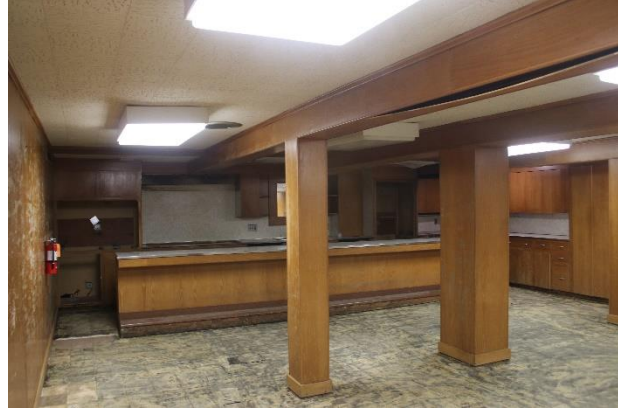
Figure 19: Cafeteria/Kitchen today.

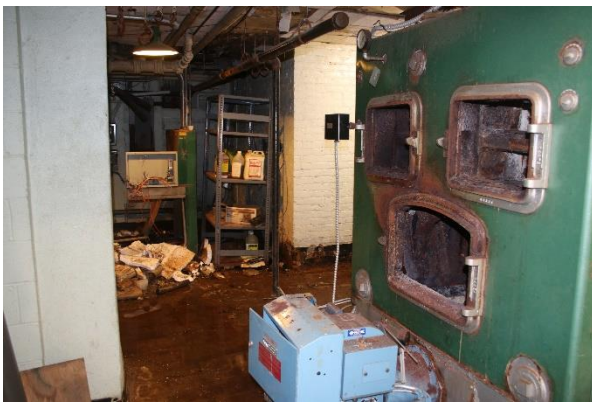
Figure 20: The cast iron doors have been removed from the old furnace.

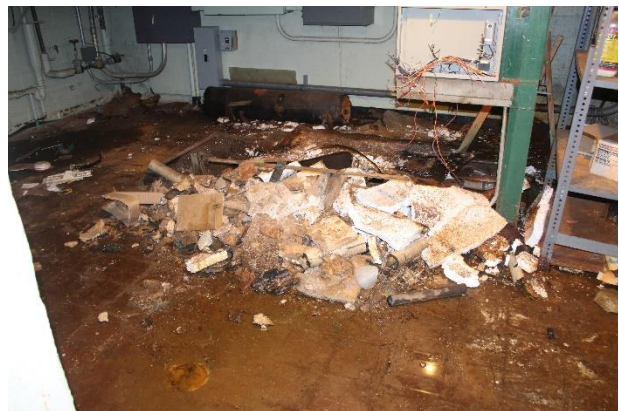
The basement has seen severe water damage, including a large quantity of standing water. Mold is a serious concern. Last year, large quantities of woodwork, tile, historic documentation and décor was removed and sent to landfill. A scrap metal collector was allowed to remove items of significant scrap value, which included most of the kitchen appliances, vault doors, doors from the coal furnace and boiler, and likely other items of preservation value of which there is no record. Although the museum director was allowed to remove some items, many were already severely damaged, and she had limited time to assess the artifacts and their context and remove them from the space.

It was believed that the water in the basement was entering via the roof leaks. However, despite the roof being repaired and a dehumidifier running constantly, new water is finding its way in, and there is still standing water on the floor.

Figure 21: Continuing water infiltration and associated damage is a major concern.

The basement is the most concerning area. It both reveals current structural issues for the building, and an interesting historic and potential future use. Certainly, the foundation damage needs repair, and the water infiltration and resultant mold problems must be addressed. It would be fascinating to see it return to being a functioning kitchen and cafeteria, perhaps a soda fountain, or even serving the same role as it did during the Great Depression: providing meals to those who are food insecure.

As a first step, consulting architects, engineers, and tradespeople should be retained to help complete a Historic Structure Report. This should precede any design work, and will allow a more thorough understanding of the history and structure of the building. Not only will evidence of the structural concerns be created and evaluated, but the document will be used to guide the development and preservation of the building.²³ Perhaps in the process of creating this report, it will be revealed that the preservation of the building is too difficult or costly. But likely the opposite will be the case if lead by a group of vision and deep concern for the continued vibrancy of the town of Culver.
